Inspection reference: 6957- 306 Chestnut St Randolph- BW

Confidential Inspection Report

306 Chestnut St
Randolph, MA 02368

June 14, 2019

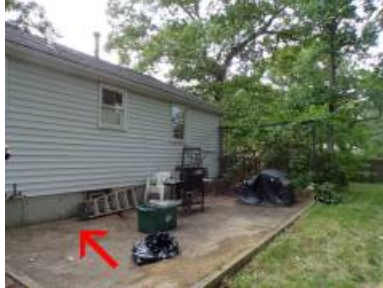
Patio

Comments: Maintenance Required, The patio, is sloped toward building. A qualified contractor is recommended to evaluate and estimate repairs.

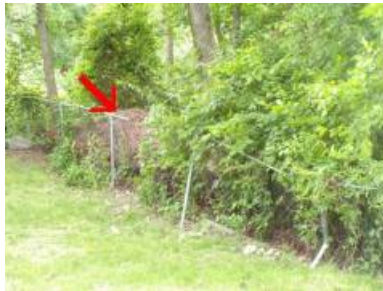
Fence

Comments: Repair/Replace/ Upgrade. The fence, is damaged. Repair or replace as needed.

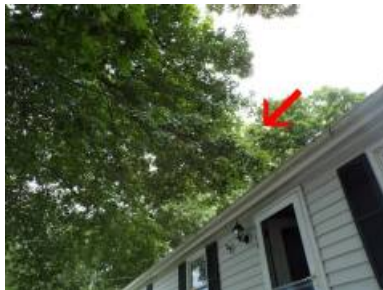
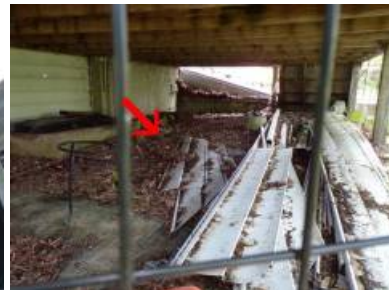
Landscaping:

Comments: Maintenance Required, The trees, are touching or overhanging the roof. Damage is possible. these trees should be trimmed. Debris, wood piles, trash and other stored items are noted against the building. These may trap moisture and attract wood destroying insects and vermin. All trash and debris, including old wood piles, should be removed.

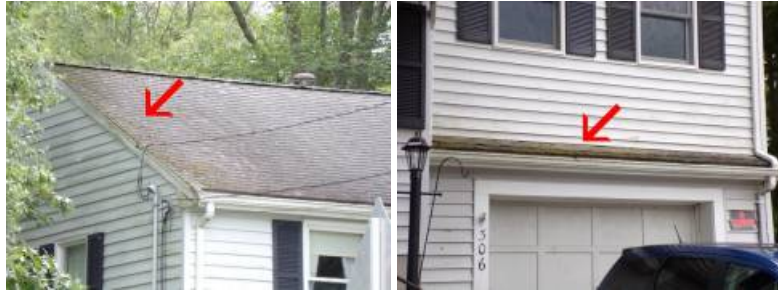
Maintenance Required. The front roof has moss algae and lichen noted growing on the

roof surface. As the moss and lichen grow into the roof they can damage the shingles. Removal of the moss and lichen growth may also remove the granular surface of the shingles. A zinc strip may eliminate moss, algae and lichen growth.

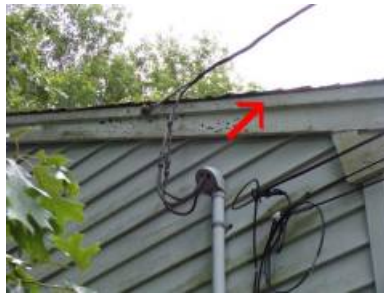
Repair/Replace/ Upgrade, Drip edge flashing is missing at the left side of the house. Drip edge flashing is recommended.

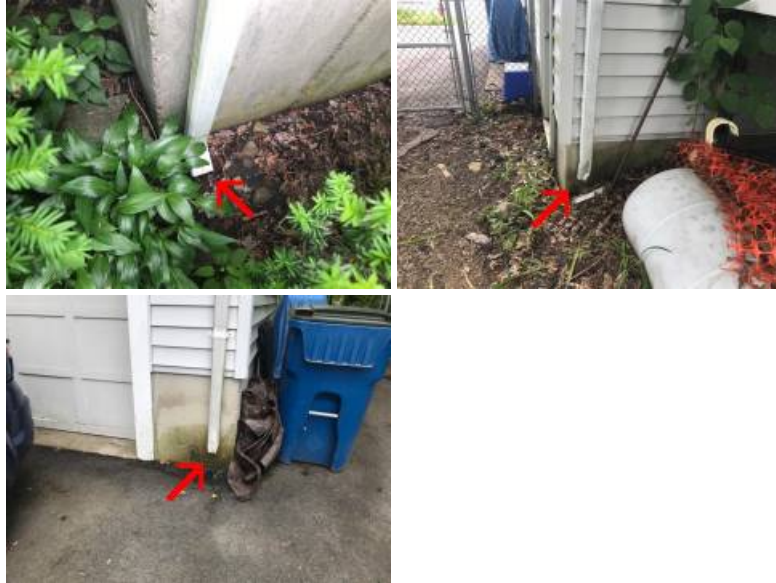
Maintenance Required, Debris is present in the gutter. The downspouts are, discharging water at the foundation. Extensions should be added to direct roof water away from the foundation.

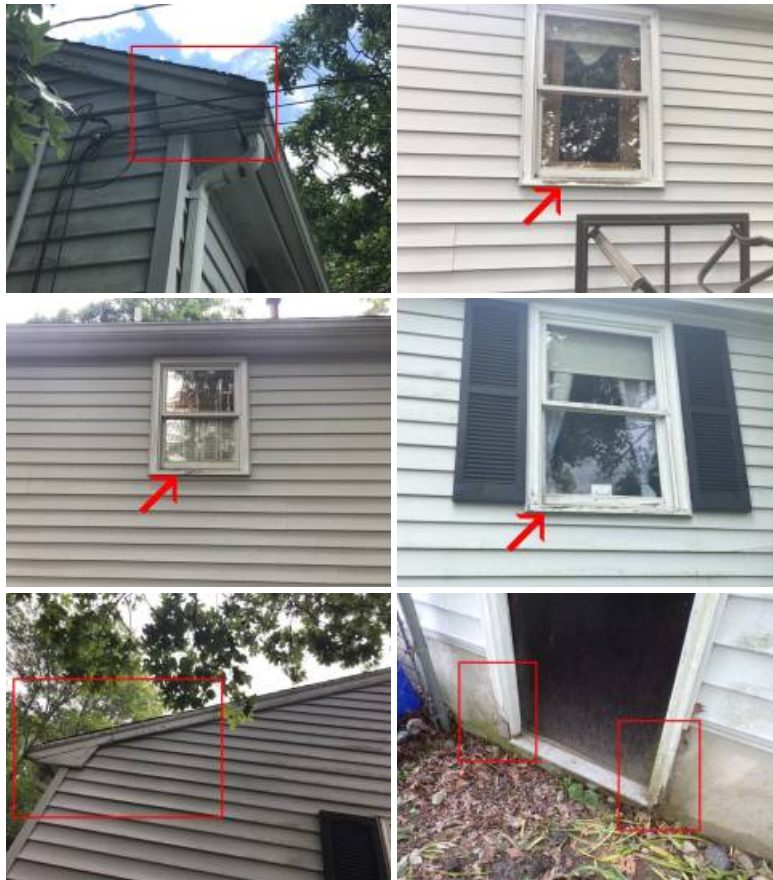
Trim

Comments: Repair/Replace/ Upgrade. The trim has peeling paint at windows and is deteriorated in certain areas. Repair or replace as needed.

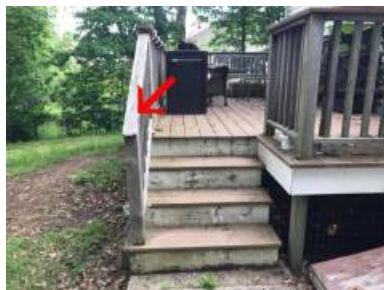
Steps, Stoops, and Landings

Comments: Repair/Replace/ Upgrade. The hand and or guard railings are, not graspable at the deck stairs. Repair or replace as needed.

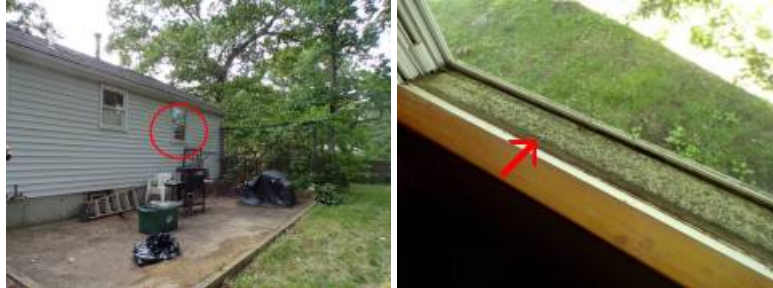
Windows:

Comments: Repair/Replace/ Upgrade, The screens are, missing at some of the windows. Moss was observed on the inside of a master bedroom window sill. Repair or replace as needed.

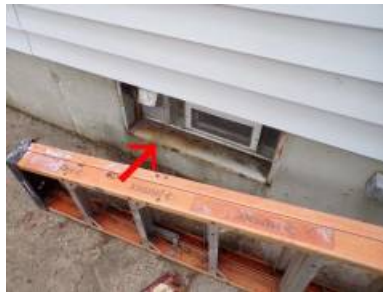
Basement Windows

Basement Window Materials metal.
Comments: Maintenance Required, The basement windows are, oxidized. Repair or replace as needed.

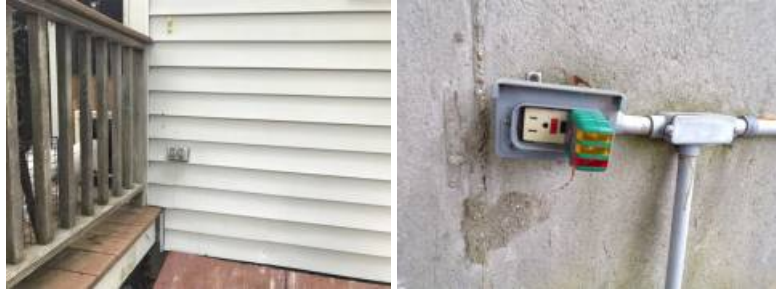
Exterior Electrical Outlets

Comments: Repair/Replace/ Upgrade, The exterior outlets, are missing a proper weather proof cover and are not GFCI protected. Update the outlets with GFCI protection. The outlet at the front of the house failed to operate. Repair or replace as needed.

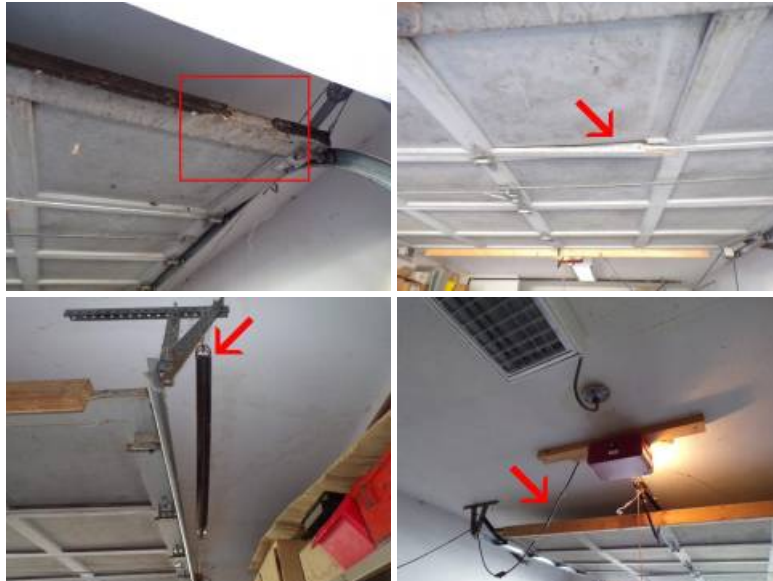
Repair/Replace/ Upgrade, The door opener automatic reverse feature is not operational, the door does not stop and retract under resistance. Note: All overhead doors should have fully operational auto-reverse function. The safety cable for the spring is missing. The weather stripping is damaged. The outlet for the door opener is not GFCI protected, it is improperly connected by an extension cord.

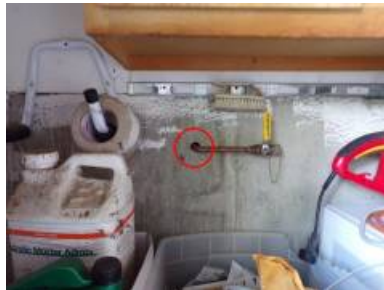
Maintenance Required, The fire separation has a gap/void where copper piping penetrates the wall. Seal the gap.

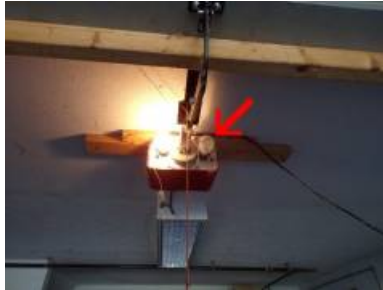
Garage Switches and Light Fixtures

Repair/Replace/ Upgrade, The light fixture at the overhead door needs a new light bulb. Repair or replace as needed.

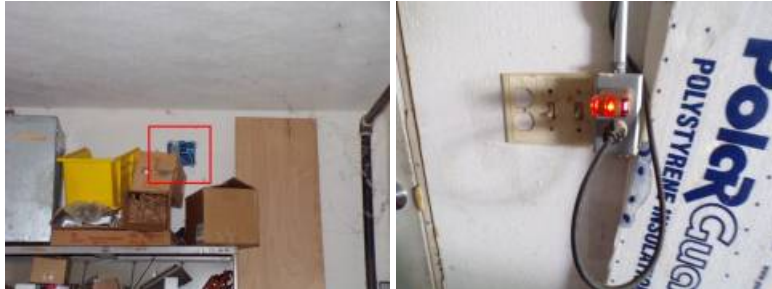
Garage Electrical Outlets

Repair/Replace/ Upgrade, The garage outlets, are not GFCI protected. Update the outlets with GFCI protection. One outlet was observed without a cover. Repair or replace as needed.

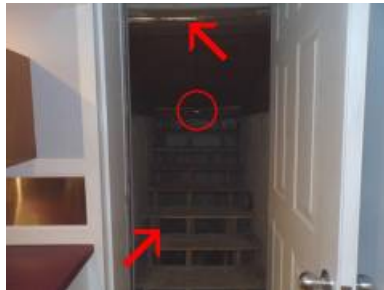
Repair/Replace/ Upgrade, The bulkhead is, improperly sealed. The bulkhead steps are missing risers. Repair or replace as needed.

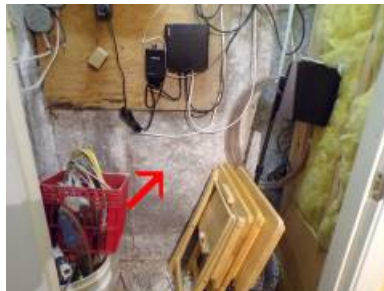
Maintenance Required, The foundation has efflorescence present. Repair or replace as needed.

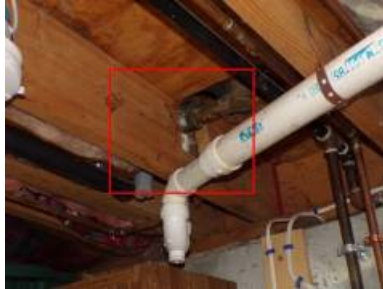
Repair/Replace/ Upgrade. There is a beam underneath the bathtub that is notched more than 1/3 into the wood member. Past moisture observed. A structural contractor should install additional supports as needed.

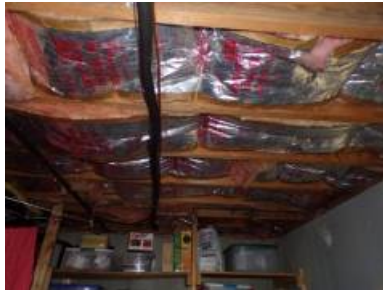
- Sill**
Comments: Acceptable, Not accessible.
- Sill Anchors**
Comments: Not accessible.
- Structure:**
Comments: Acceptable, Not accessible.
- Sub-Floor**
Comments: Not accessible.
- Insulation**
Material fiberglass bats.
Comments: Repair/Replace/ Upgrade, The insulation between conditioned and unconditioned spaces has an improperly installed vapor barrier. Repair or replace as needed.

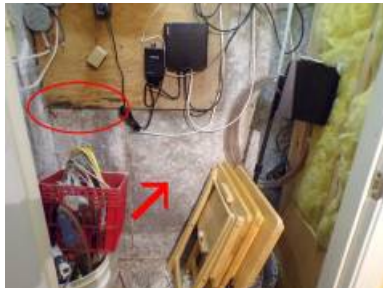
- Moisture Control**
Disclaimer

Maintenance Required, Evidence of high moisture was noted in the basement. This can lead to mildew and wood rot. The home inspection is non-invasive and is based on visual observations only. No moisture readings were taken at the time of inspection. Based on visual observations further review of water staining is recommended. Use of a properly sized dehumidifier is recommended.

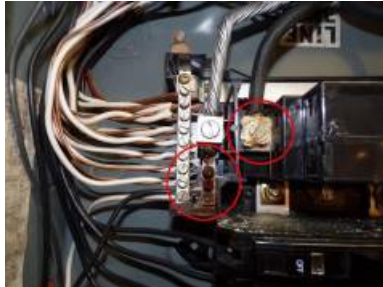
Main Service Panel:

Location: Basement.
Comments: Repair/Replace/ Upgrade, Corrosion is noted at the breakers. Upgrade with AFCI circuit breakers, A qualified electrician is recommended for further evaluation and to estimate repairs.

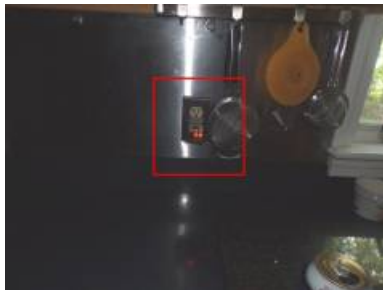
Ground Fault Circuit Interrupters

Comments: Repair/Replace/ Upgrade, GFCI protection is not present at the kitchen. GFCI protection recommended for safety. A qualified electrician is recommended for further evaluation and to estimate repairs

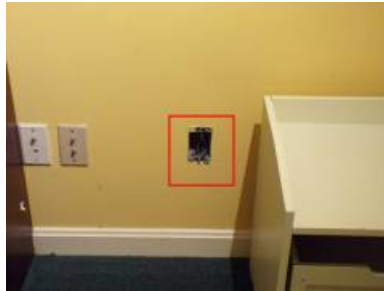
Repair/Replace/ Upgrade, Some junction boxes are improperly secured or missing covers.

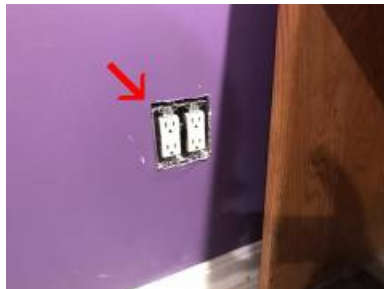
Repair/Replace/ Upgrade, Missing or damaged cover plates viewed. Repair or replace as needed.

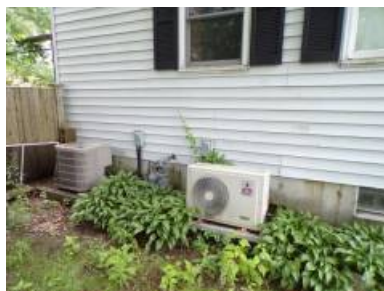
Repair/Replace/ Upgrade, A GFCI protected outlet is not present at the AC equipment. Install a GFCI protected outlet at the exterior AC equipment, A qualified electrician is recommended for further evaluation and to estimate repairs.

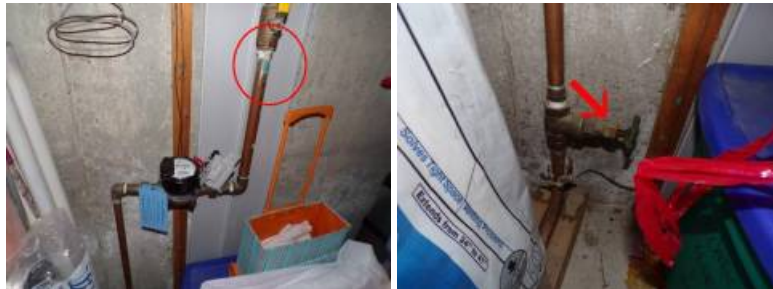
Repair/Replace/ Upgrade, The main supply pipe is is oxidized at the pipe, valves and fittings, and has older gate valves. These valves may leak when operated after years of no use. A qualified licensed plumber is recommended for further evaluation and to estimate repairs.

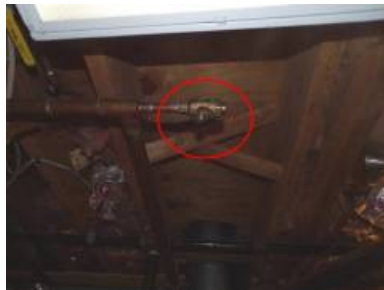
Repair/Replace/ Upgrade, One supply pipe was observed as improperly terminated in the laundry area. A qualified licensed plumber is recommended for further evaluation and to estimate repairs.

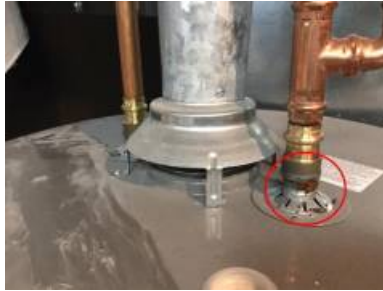
Maintenance Required. There is build up at the cold water inlet connection. A qualified licensed plumber is recommended for further evaluation and to estimate repairs.

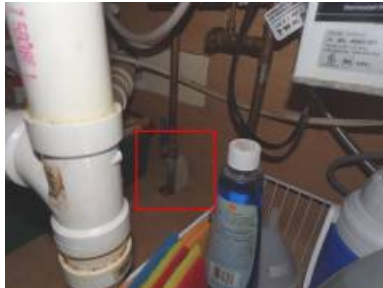
Kitchen Sink:

Repair/Replace/ Upgrade, the supply lines, are oxidized at valves and fittings. Repair or replace as needed.

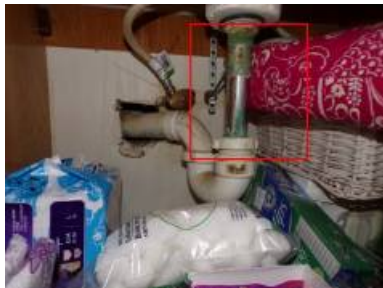
Bathroom Sinks

Repair/Replace/ Upgrade, Safety Hazard. The faucet had a water temperature of 145 degrees fahrenheit at the time of inspection. At this temperature, the water may cause scalding. The drain pipe is oxidized at the 1st floor bathroom. A qualified licensed plumber is recommended for further evaluation and to estimate repairs.

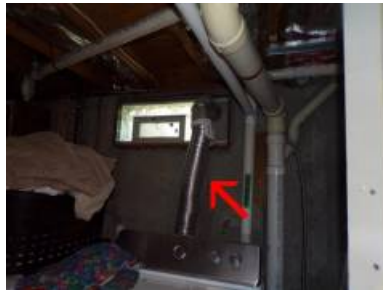
Repair/Replace/ Upgrade, This type of vent may trap lint which is a fire hazard. Replace with a smooth metal vent.

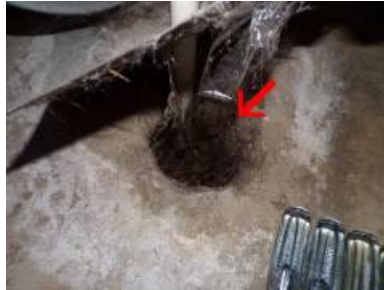
Repair/Replace/ Upgrade, The condensate line has an improper discharge point into the basement floor. Repair or replace as needed.

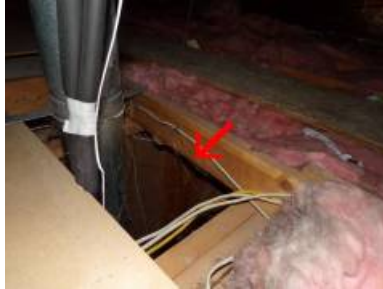
Comments: Maintenance Required, The floor, is missing where refrigerant pipes pass through the attic floor. Repair or replace as needed.

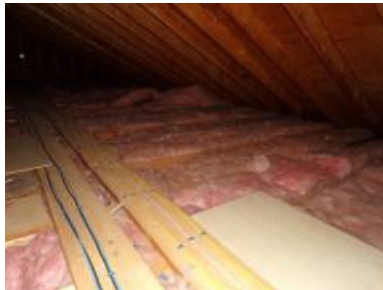
Insulation

Type/Depth: The visible insulation consists of, Fiberglass bats, The insulation Depth/R Factor is, 5-6 inches.
Comments: Repair/Replace/ Upgrade, Insufficient. The amount of insulation does not conform to modern standards of energy efficiency, Additional insulation is recommended.

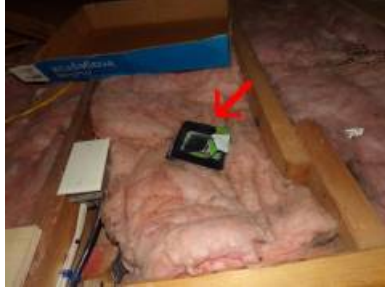
Additional Comments Evidence of rodent activity was noted. You may wish to have treatment carried out by a licensed exterminator. Steps should be taken to prevent further entry by pests.

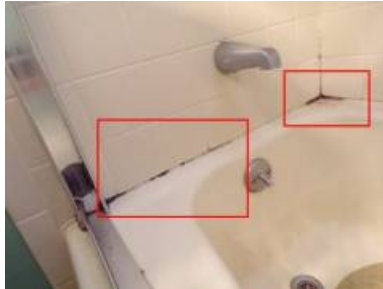
Tub/Shower/Bathroom Walls Ceilings and Floors

Comments: Maintenance Required, The grout and caulking is deteriorated at the bathroom tub/shower. Repair or replace as needed.
